Manhole Inspection Summary

Manhole # S31M1_017MH

Location Address: **650 Hillview Road**

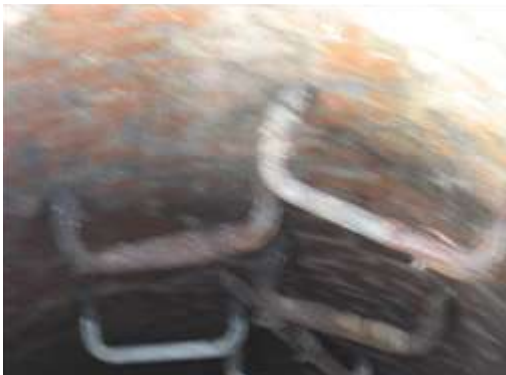
Count: **5** Missing: **0** ☐ Corroded

steps

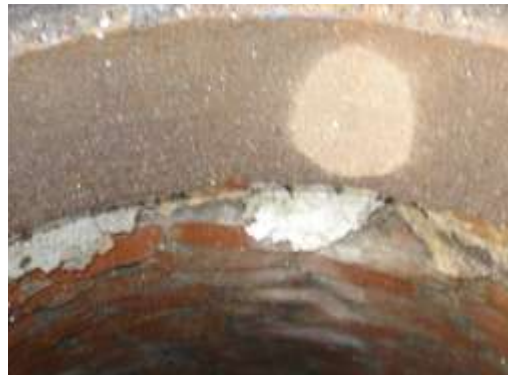
Defect 1

Condition: ☐ Sound ☐ Cracked ☐ Root Intrusion ☒ **Loose Brick** ☐ Deteriorated

loose bricks under frame

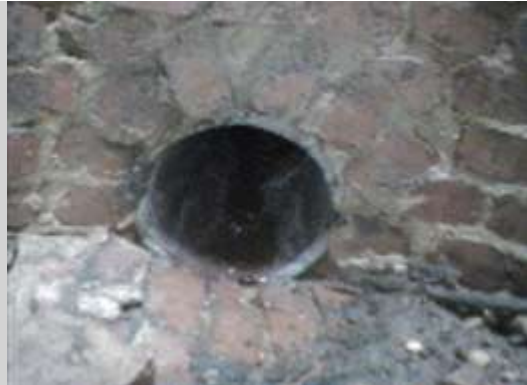
12 O'Clock Outflow

8 in. Circular Gravity Sewer
Pipe Out @ 12 O'Clock

Infiltration: **None** Pipe Seal Cond: **Sound**
